REPORT OF MARINE SURVEY

PRE-PURCHASE CONDITION & VALUE of the vessel

"Our Yacht" 1990 Hatteras 52' Cockpit Motor Yacht

**on
1/28/2011**

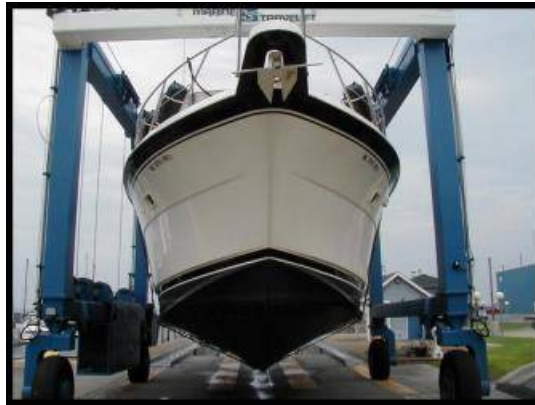
Construction material:

Hand laid and molded fiberglass with white gel coat surface.

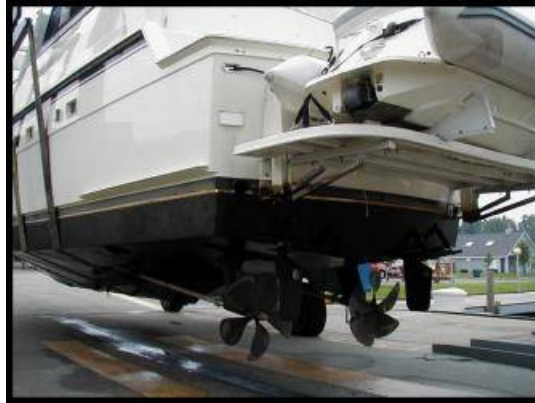
Fiberglass attached, Powered TNT swim platform that is fully functional and includes a remote control. Weaver davits well secured to swim platform.

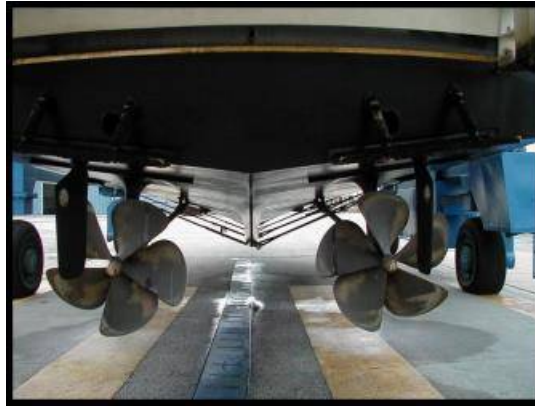
Prop(s) description:

Prop(s) built by Federal Props have five blades and are made of Nibral, prop hub stamped with a diameter of 36" - Pitch not marked. Props are in excellent condition. No bent, chipped or damaged prop blades.

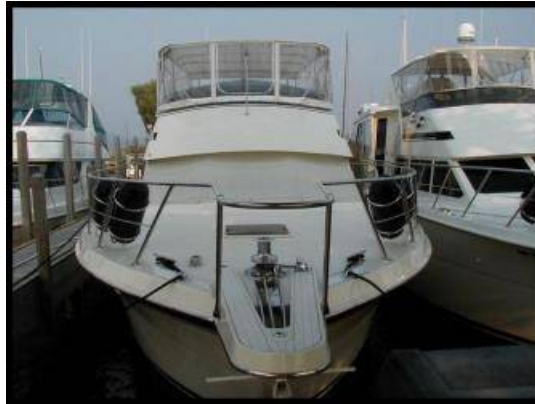
Deck Surface:

Molded fiberglass with Balsa core sandwich construction. White gel coat with molded in non skid fiberglass surface. Good condition. Deck is solid under foot, no soft spots discovered and no visible cracks or chips sighted.

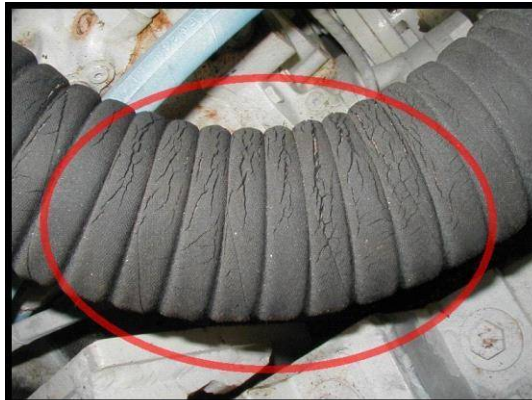
Cracked raw water hose

Raw water intake hoses are showing signs of age cracking along most of its length. The hose(s) appear firm with no soft or spongy areas. Although the hose appears to remain serviceable it cannot be determined when the hose will burst through. **RECOMMENDATION: Replace the engine raw water cooling hose(s)**

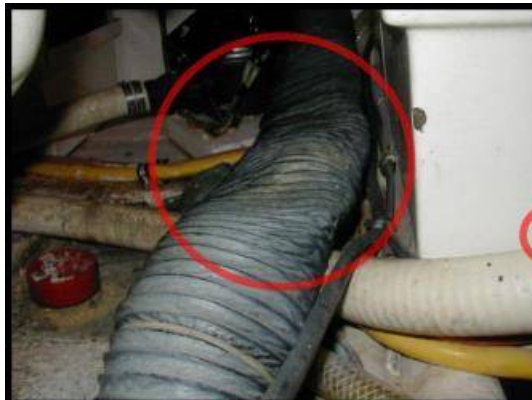
Engine ventilation:

Natural ventilation for engine space is provided. Power exhaust ventilation blower(s) are installed and power up. **The bilge blower hose for the Port engine is partially collapsed forward of the engine. RECOMMENDATION: Replace collapsed vent hose to allow proper ventilation of the engine compartment.**

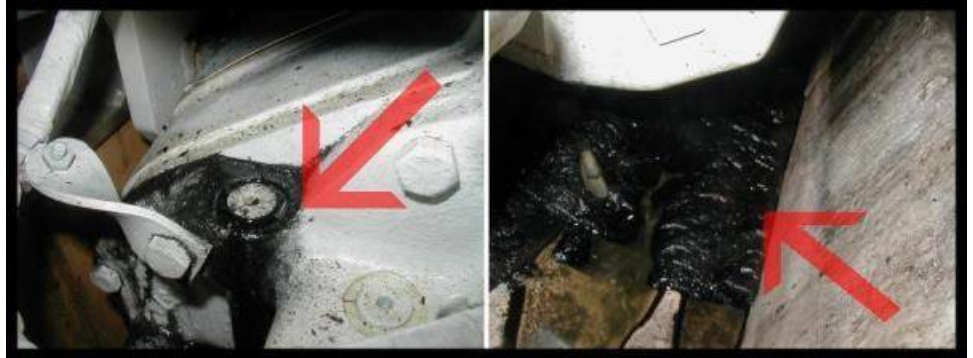
Starboard drip pad was dry and clean. The Port side drip pad is fully saturated with oil and water. The Port engine has evidence of oil leakage at back of engine. **RECOMMENDATION:** Identify sources of oil/water leakage and correct as necessary. Install fresh drip pads after repair.

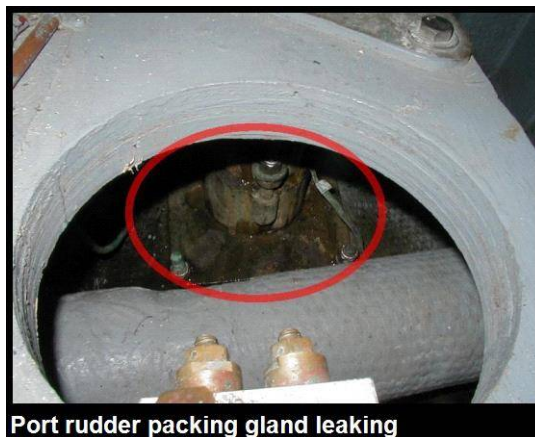
Packing glands:

Port side rudder packing gland shows evidence of water leakage. **RECOMMENDATION:** Replace or adjust packing glands to prevent any water intrusion. **NOTE:** Rudder packing glands should always be totally dry. Check frequently and adjust if necessary.
