REPORT OF MARINE SURVEY

PRE-PURCHASE CONDITION & VALUE of the vessel

"Our Yacht" 1990 Hatteras 52' Cockpit Motor Yacht

**on
1/28/2011**

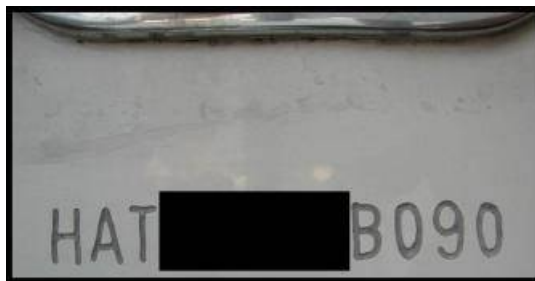
Hull ID number (HIN):

HATxxxxxB090 - A true digital photograph of the hull ID number of the referenced vessel is shown here. (Modified for Sample Report to protect privacy)

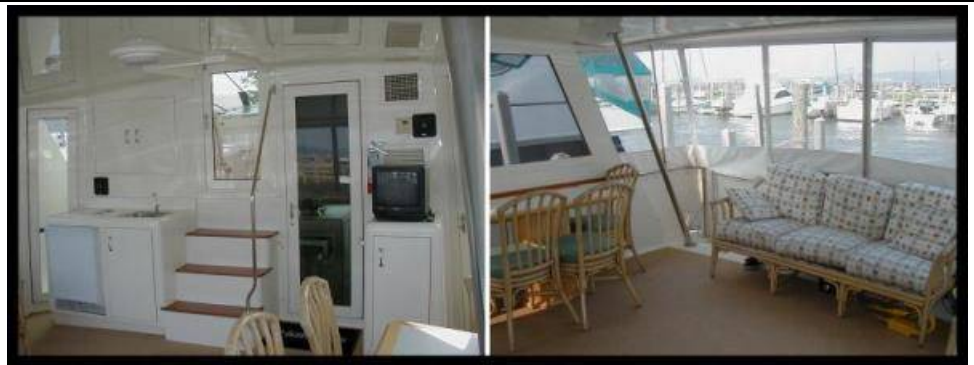
Construction:

- Sole:** FRP (fiber reinforced plastic) with molded in non skid, with carpet cover. Carpet in excellent condition with snap downs in place.
- Scuppers/deck drain(s):** Yes. Drains are clear, hoses secure.
- Deck equipment:** Sink/Wet bar has, sink is stainless steel w/ cold pressure faucet, Refrigerator(s)/ice maker(s): U-Line ice maker-AC Powered, Refrigerator/Icemaker powers up OK. Rattan sofa and table/chairs with cushions. All in excellent condition.
- Canvas:** Full canvas enclosure with zip out plastic windows, and with zip out screens All

canvas, side curtains and isinglass appeared to be in good condition.
Aft deck fully air conditioned and carpeted.

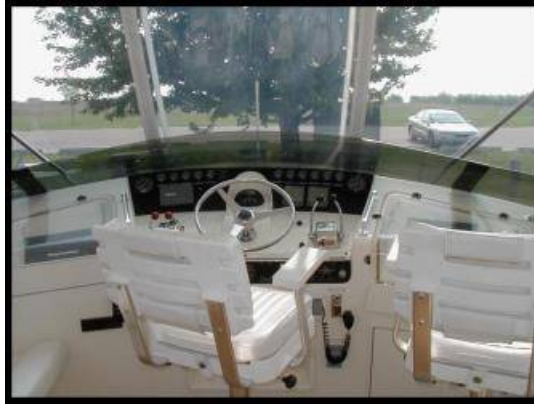
Helm station:

- Compass(es):** 6" Ritchie Powerdamp, Mounted at upper helm. Appears functional.
- VHF radio(s):** ICOM IC M-422 Mounted at upper helm. Powers up OK, Serial no was not sighted. Unit is built in.
- Autopilot(s):** Raymarine ST8001+ Mounted at upper helm. Powers up OK, Serial no was not sighted. Unit is built in.
- Multi-function instrument(s):** Raytheon Tri Data, Mounted at upper helm. Powers up OK, Serial no was not sighted. Unit is built in.
- GPS:** Raytheon ST60 Mounted at upper helm. Powers up OK and appears functional. Serial no was not sighted. Unit is built in.
- Radar:** Furuno FR-7040D with 12" display, Display mounted at upper helm Powers up OK, Serial no was not sighted. Unit is built in.

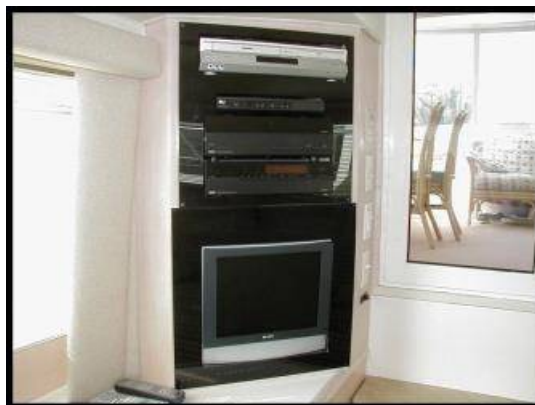
Other notes:

All Main Salon electronics are built in/mounted in an electronics bank as shown.

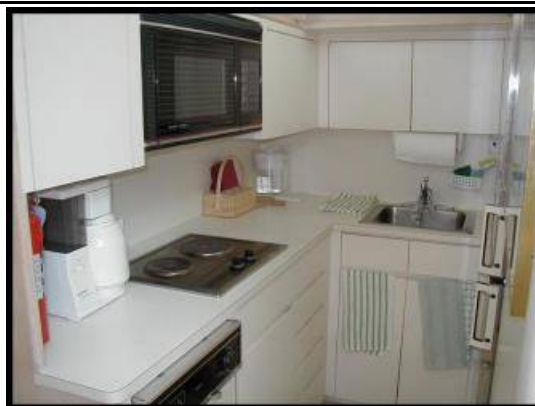
Location:

Port side step down off main salon.

- Stove:** Roper, two burner, electric, Burners tested and are functional. Power indicator lights are functional.
- Refrigeration:** Upright, Frigidaire Model FP1F1117BEED1, 110V, with freezer. Door safety lock is installed and functional. Powers up OK.
- Water system:** Pressurized hot and cold, Tests OK as pump holds pressure without cycling.
- Sink(s):** Single stainless steel deep well, Drains overboard.
- Microwave oven:** Sharp Carousel II, Convection oven, Unit is built in and well secured. Powers up OK and appears functional. Serial no was not sighted. Unit is built in.
- Coffee maker:** Black and Decker Space Maker, Not tested.
- Dishwasher:** Kenmore built in and well secured, Not tested.
- Garbage disposer:** Yes- not tested.
- Vent fan:** Powered vent exhaust fan is operational.
- Storage:** Appears to be adequate.

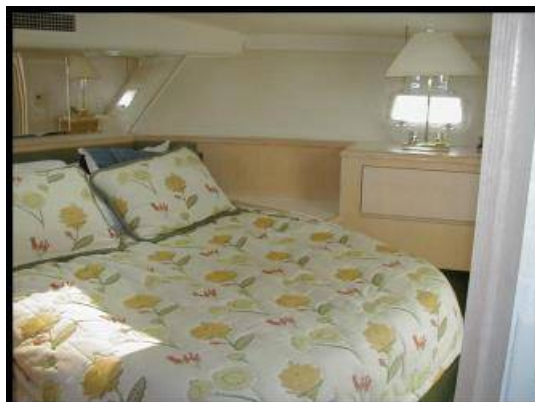
Master stateroom:

In V-berth area, Amenities include: Raised island bed with custom sized mattress. Private head, Cedar lined hanging closet. TV ---See entertainment electronics section for all details.

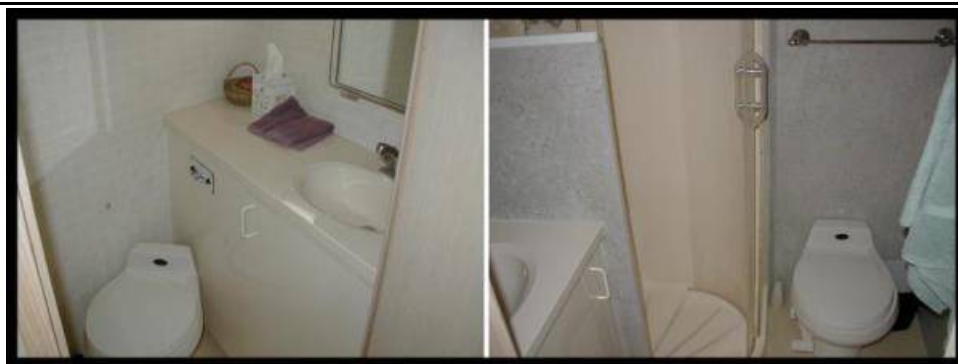
Number/Location:

Two heads located in master stateroom and aft near guest staterooms. Raritan, Electric flush pump, Appeared functional when tested. No leaks sighted. Raw water intake thru bronze seacock. Hose secure. Solid surface Hot & Cold pressure water fixture at sinks, Drains overboard. Stand up or sit down shower stall in each head. Powers up and functional. Located in sump tank with auto float and Rule 800 GPH automatic bilge pump. Not tested-Float inside sealed sump container.

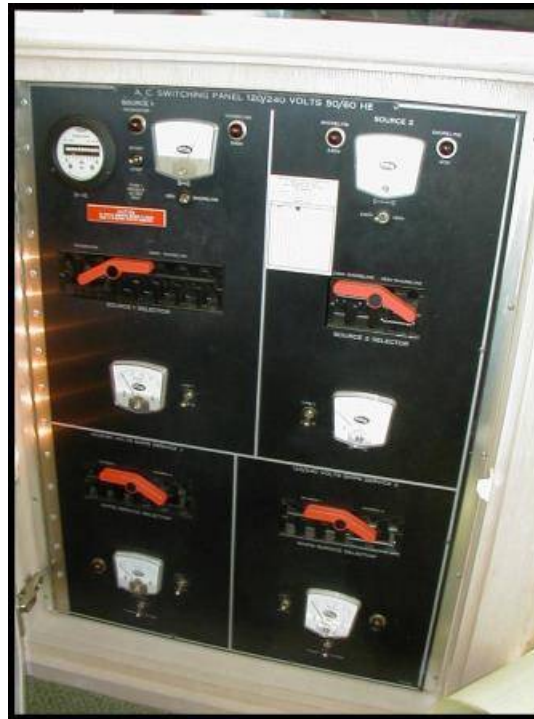
A.C. Voltage system:

50 Amp - 120/240 Volt system One inlet plus Glendinning unit.

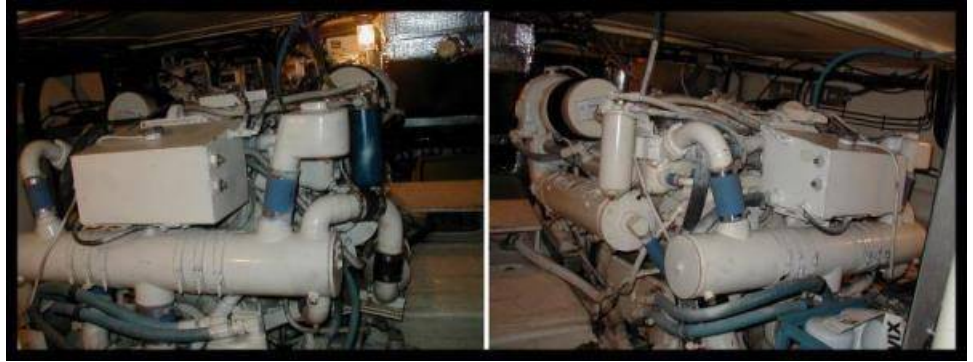
No./Type/Cylinders

Two, Detroit Diesel 8V92TA, Inboard V8 Turbo After cooled.

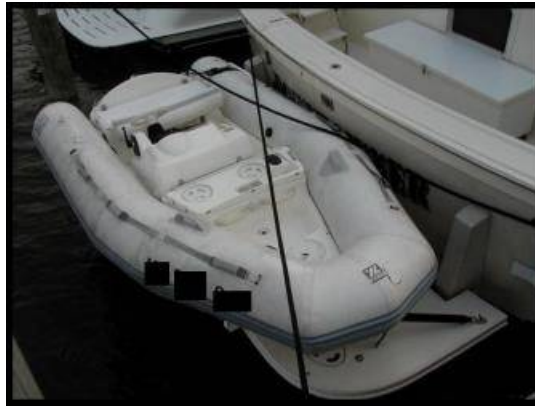
Manufacturer/Model:

2000 Zodiac Projet 350.

Type: Inflatable- Neoprene, with FRP Hard bottom.

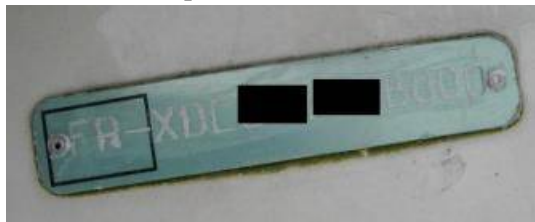
Hull ID number verification:

XDCxxxxxB000 A true digital photograph of the hull ID number of the referenced vessel is shown here. (Modified for sample report to protect privacy.)

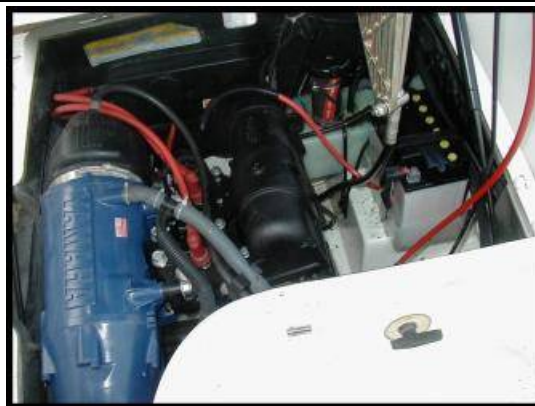
Motor manufacturer:

Yamaha 2 cylinder inboard water jet propulsion system installed in the above dinghy/tender.

Model & serial number: Not sighted on engine.
